ARBORIST REPORT  
AUTUMNWOOD  
(SELECT SYCAMORE TREES)

Prepared by  
Wayne Farnsworth  
BrightView Tree Care Services  
ISA Certified arborist  
WE-11703A

Date : December 12, 2017

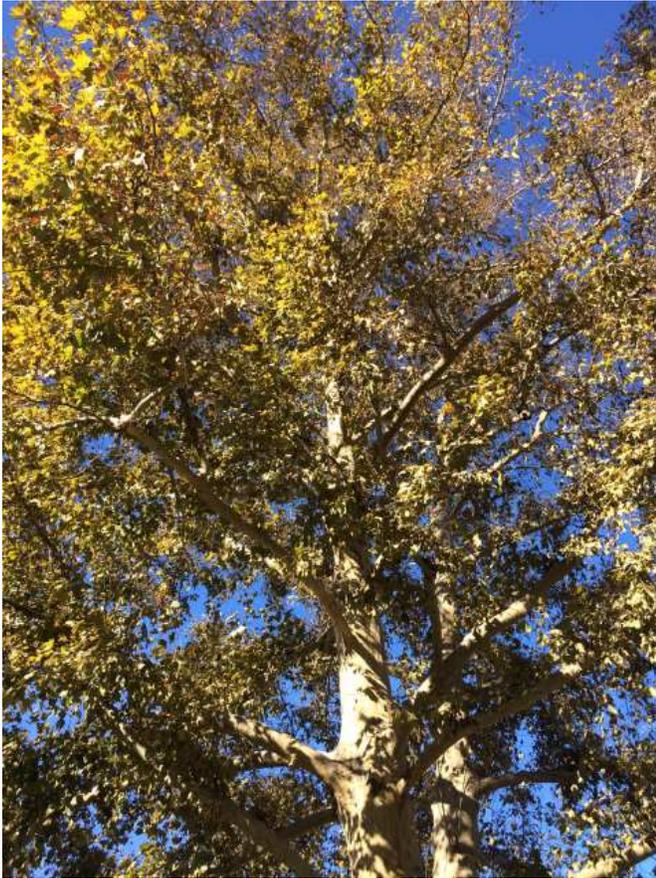
**1. California Sycamore Tree Tag 51 and 52- DBH 31-36" Health good**

**Notes:** These tree is located in a planter area near oak haven. During our inspection we found that both of these trees were in good health overall and had a nice branching structure (evenly spaced scaffolding branches) and a strong central leader. Trees with these characteristics are more structurally sound and cost effective to maintain. There were no signs of insect damage or plant diseases at the time of inspection (basic visual inspection with sounding hammer to check for decay). Both had a slight lean away from each other which developed in order to obtain more sunlight but it doesn't seem excessive and it doesn't appear to be due to anchorage.

Pictured above are the two California Sycamore trees (tag 50 and 51). Note both trees have a strong central leader and evenly spaced scaffolding branches

**Recommendation:** Our recommendation at this time is to perform minor reduction and thinning cuts on the outermost portion of the canopy. This will help to maintain the strong structure it currently has as well as help to prevent major branch failure. Due to the close proximity of these trees to nearby homes a basic annual inspection is recommended. This can be informal and done alongside the annual trimming.

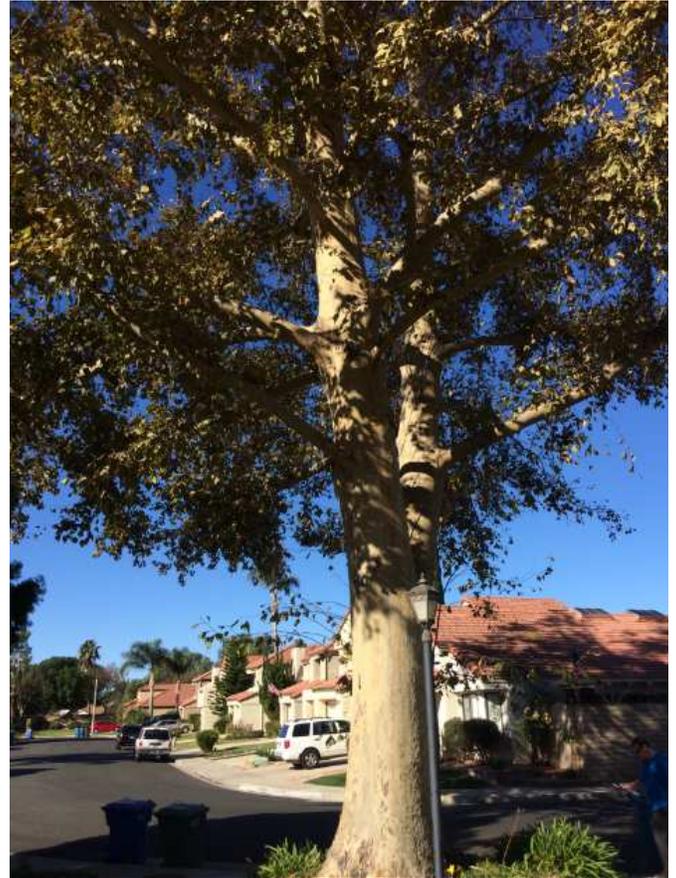
Pictured above are the two California Sycamore trees (tag 50 and 51). The branches pictured above have good taper and have a lower aspect ratio in relation to the trunk. Branches that have a lower aspect ratio have a stronger attachment to the trunk

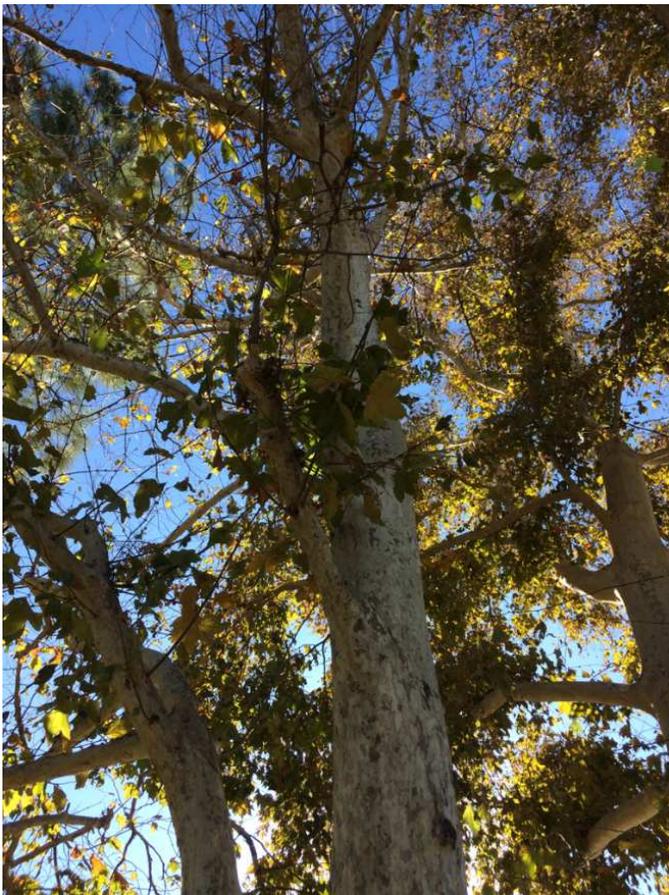
**Notes:** These trees is located in a planter area near 2224 and 2226 Oak Haven circle. During our inspection we found the trees were in good health overall and had a nice branching structure (evenly spaced scaffolding branches) and a strong central leader. During our inspection we found tree tagged 106 to have low-moderate amount of deadwood present in the canopy this is common for this species of tree and is just a minor issue. This tree was also the smallest of the three present and would benefit from structural pruning. The two trees 104 and 105 have a slight lean away from each other.

Pictured above is California sycamore tree tag 106. Note the moderate deadwood in the canopy and the twisting branch structure.

**Recommendation:** Our recommendation at this time is to perform minor reduction pruning on the outer most limbs in order to maintain the current structure on trees 104 and 105. This will help to maintain the strong structure it currently has and help to prevent major branch failure. Regular deep watering should be performed (a few feet day once a month 2-3 feet deep past the drip line). On California sycamore tree tag 106 the deadwood should be removed in order to facilitate proper wound closure. This tree would also benefit greatly from structural pruning. Due to their size and proximity to nearby homes these trees should be inspected annually prior to pruning.

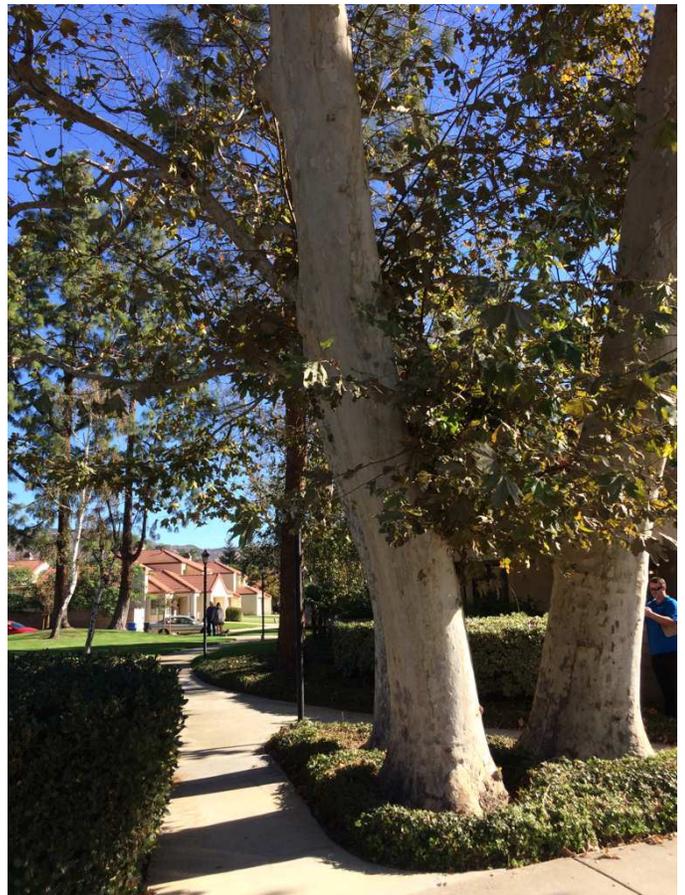
Pictured above at California Sycamore tree tag 104 and 105. Note the root flairs are healthy and present. These trees have a slight lean away from each other but otherwise appear healthy.
