ARBORIST REPORT  
AUTUMNWOOD  
(SELECT SYCAMORE TREES)

Prepared by  
Wayne Farnsworth  
BrightView Tree Care Services  
ISA Certified arborist  
WE-11703A

Date : December 12, 2017

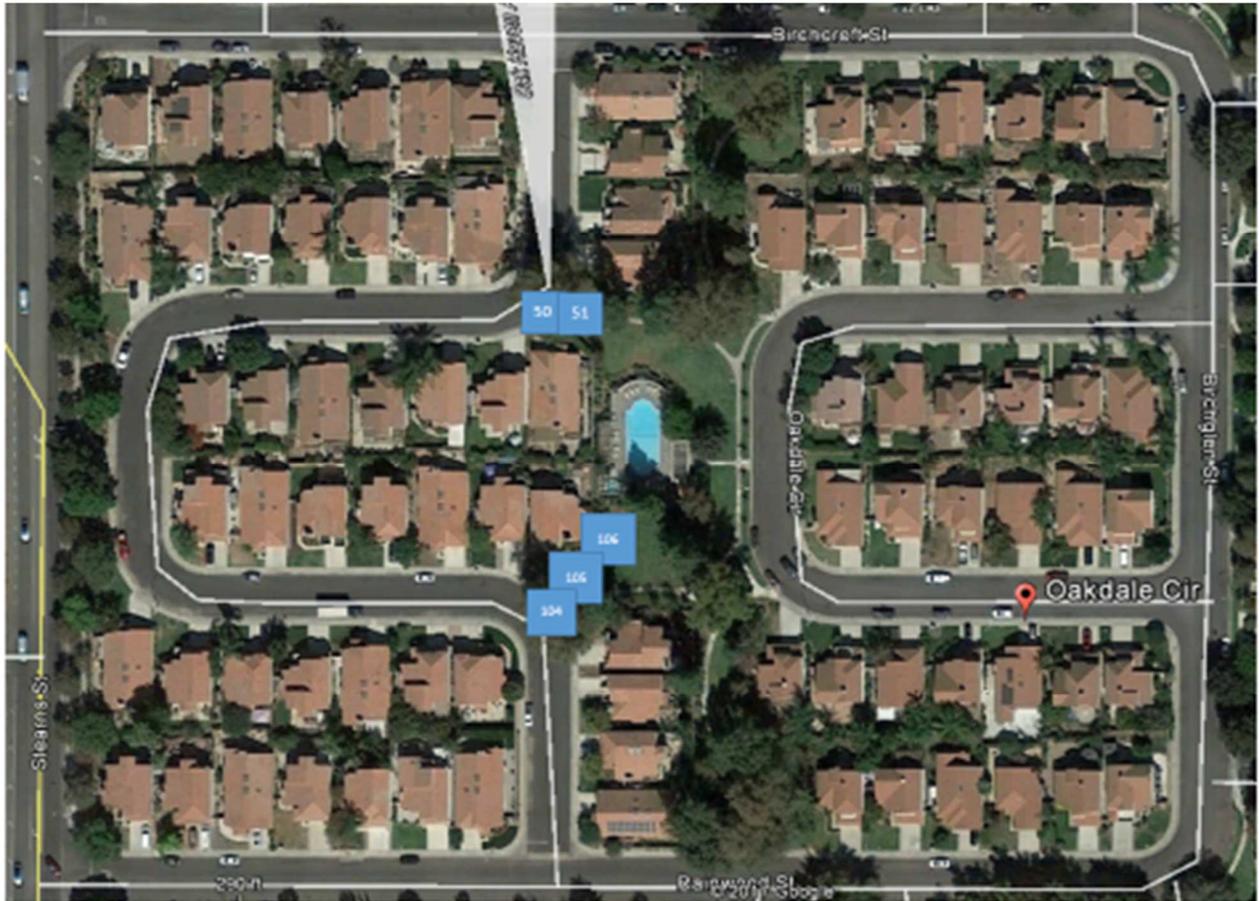
**1. California Sycamore Tree Tag 51 and 52- DBH 31-36" Health good**

**Notes:** These tree is located in a planter area near oak haven. During our inspection we found that both of these trees were in good health overall and had a nice branching structure (evenly spaced scaffolding branches) and a strong central leader. Trees with these characteristics are more structurally sound and cost effective to maintain. There were no signs of insect damage or plant diseases at the time of inspection (basic visual inspection with sounding hammer to check for decay). Both had a slight lean away from each other which developed in order to obtain more sunlight but it doesn't seem excessive and it doesn't appear to be due to anchorage.

**Recommendation:** Our recommendation at this time is to perform minor reduction and thinning cuts on the outermost portion of the canopy. This will help to maintain the strong structure it currently has as well as help to prevent major branch failure. Due to the close proximity of these trees to nearby homes a basic annual inspection is recommended. This can be informal and done alongside the annual trimming.
